**Evaluation of Public Safety at Run-of-River Dams
An Illinois State Wide Program**

JULY 20, 2007

APPENDIX V – Dam Investigations

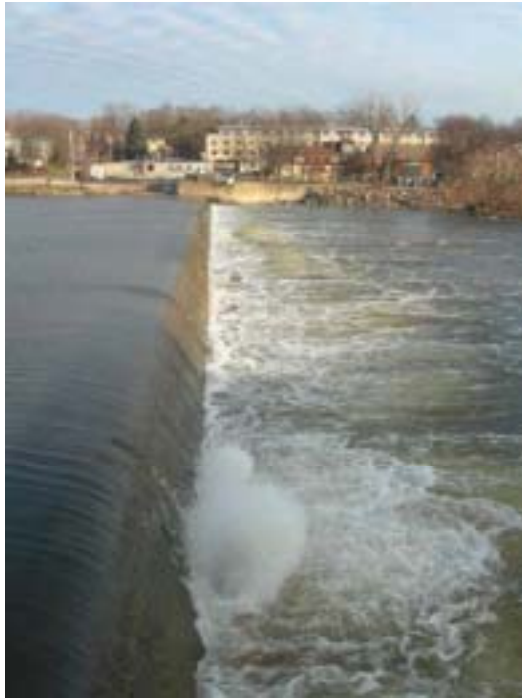
Photo 5.3.7.2 - 1 - Geneva Dam, Fox River
Dam face, taken from right abutment. Note debris in roller.

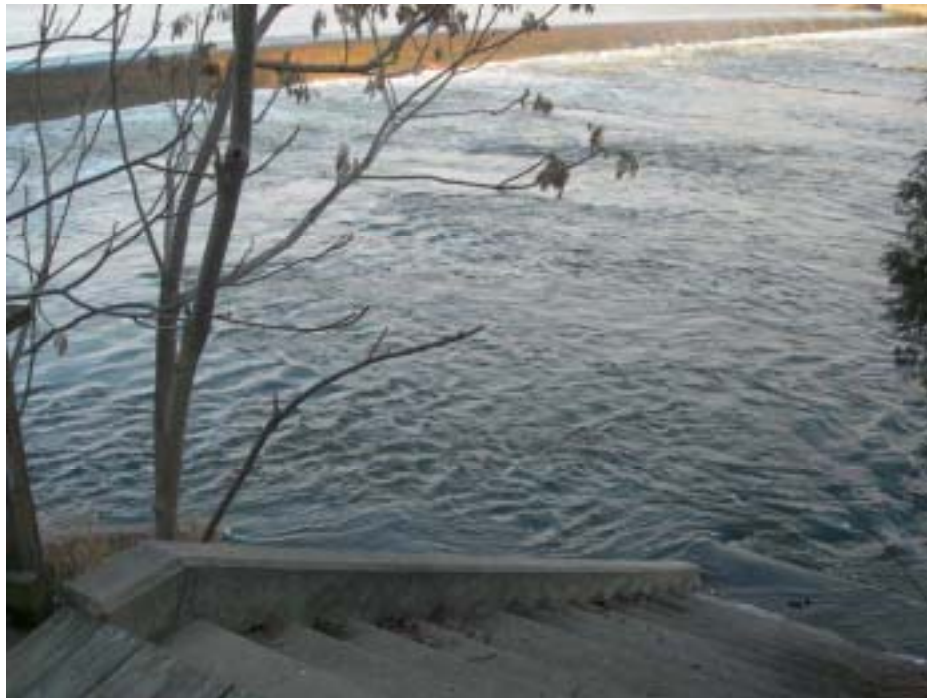
Photo 5.3.7.2 - 2 - Geneva Dam, Fox River
Downstream right bank. Portage/stairs.

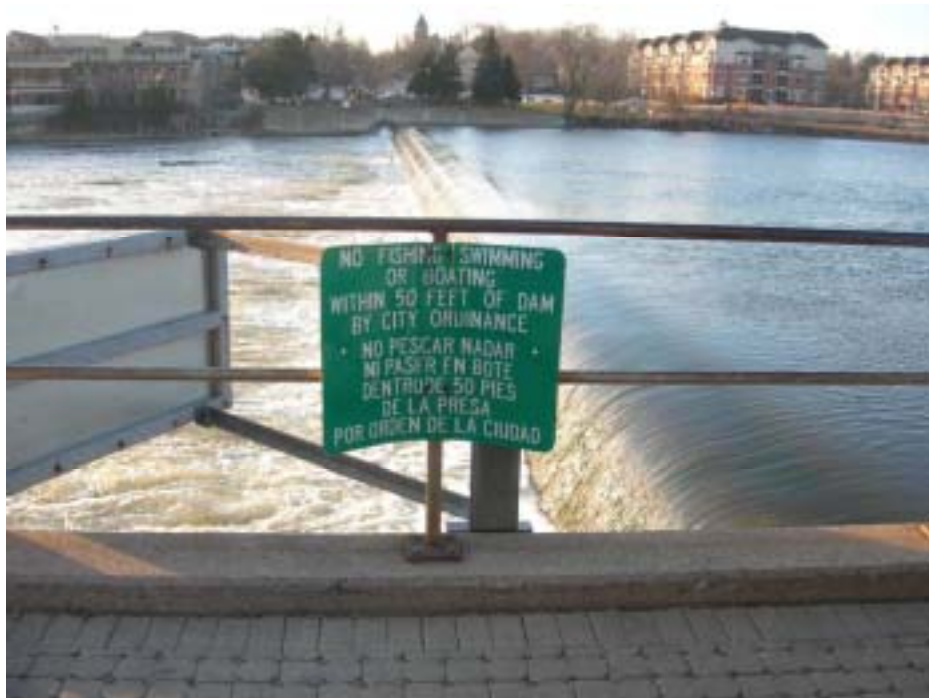
Photo 5.3.7.2 - 4 - Geneva Dam, Fox River

Left Abutment. Warning sign posted by City of Geneva.

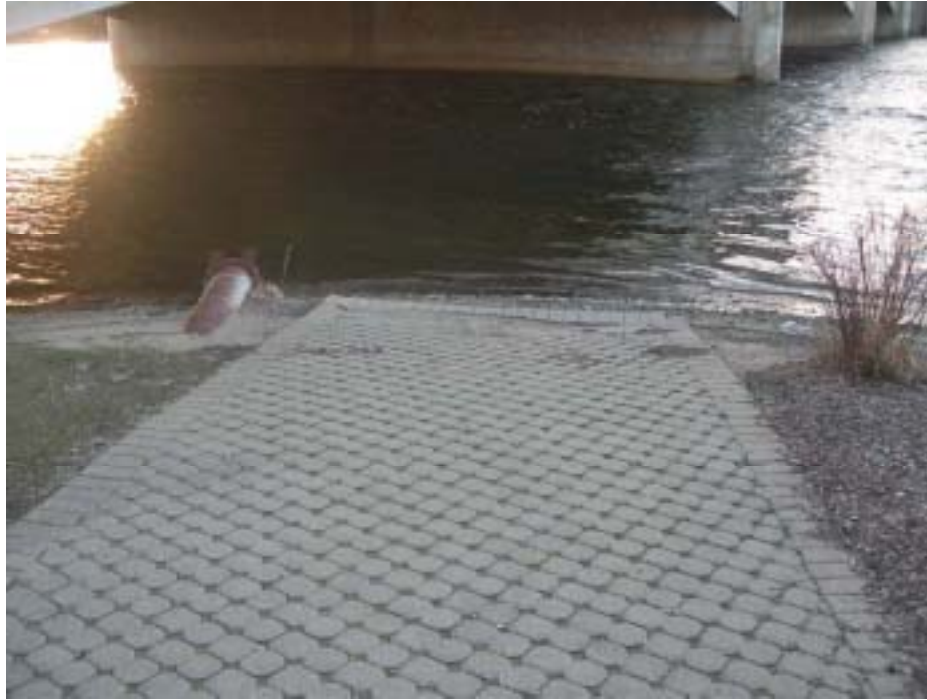
Photo 5.3.7.2 - 5 - Geneva Dam, Fox River
Left bank, looking upstream. Portage ramp with rail.

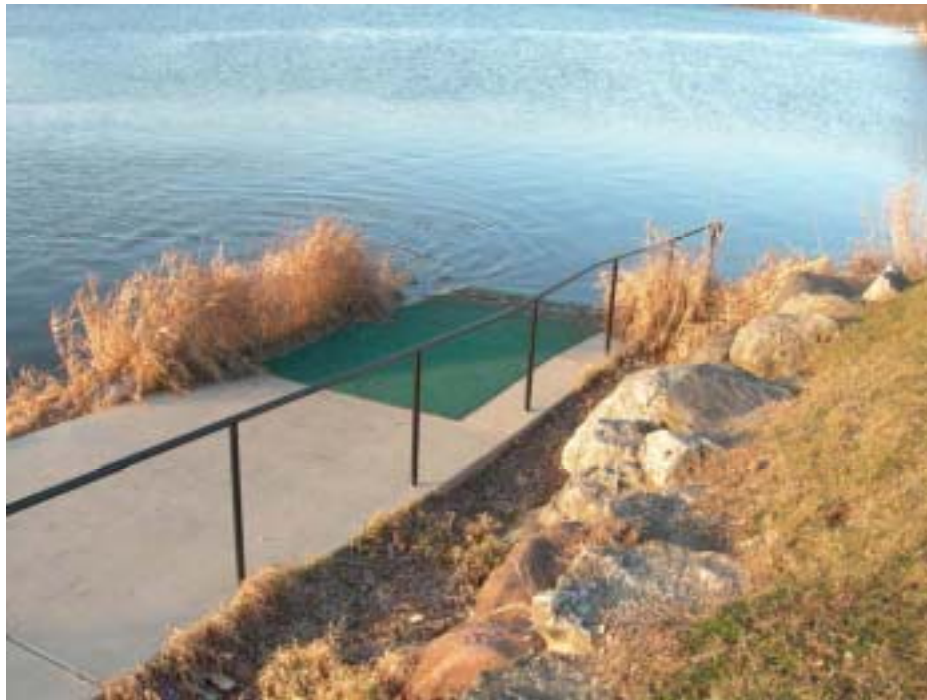
Photo 5.3.7.2 - 6 - Geneva Dam, Fox River
Left bank, downstream of dam face. Portage/boat launch.

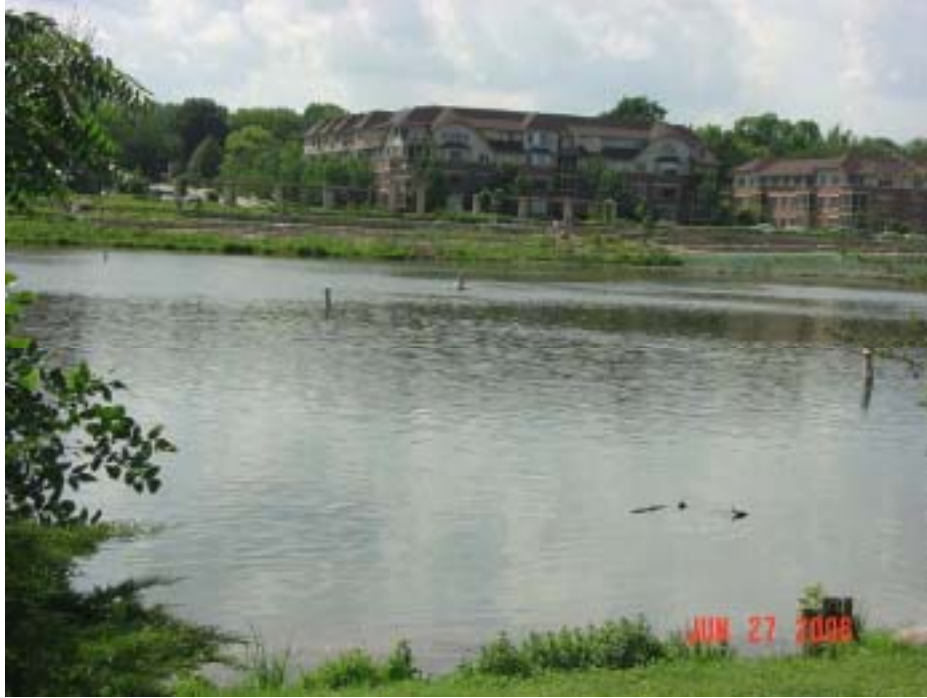
Photo 5.3.7.2 - 7 - Geneva Dam, Fox River
Seasonal Warning Buoys (IDNR, 2006)

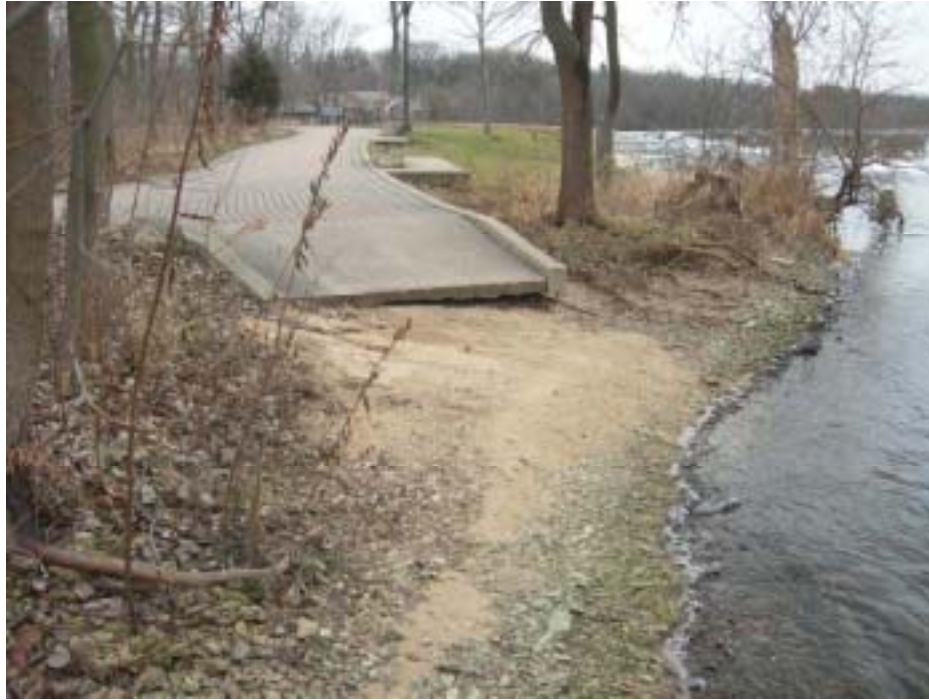
Photo 5.3.8.2 - 5 - Batavia North Dam, Fox River
Right bank, downstream. Boat launch/portage.

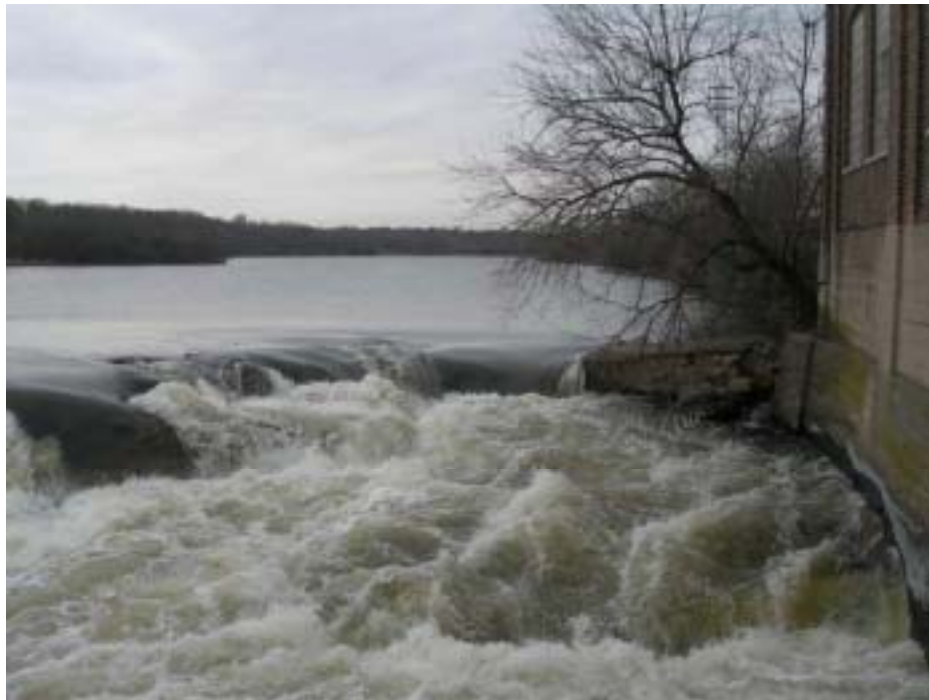
Photo 5.3.8.2 - 6 - Batavia North Dam, Fox River
Dam face left abutment. Breached portion of dam. Heavy white water rapids.

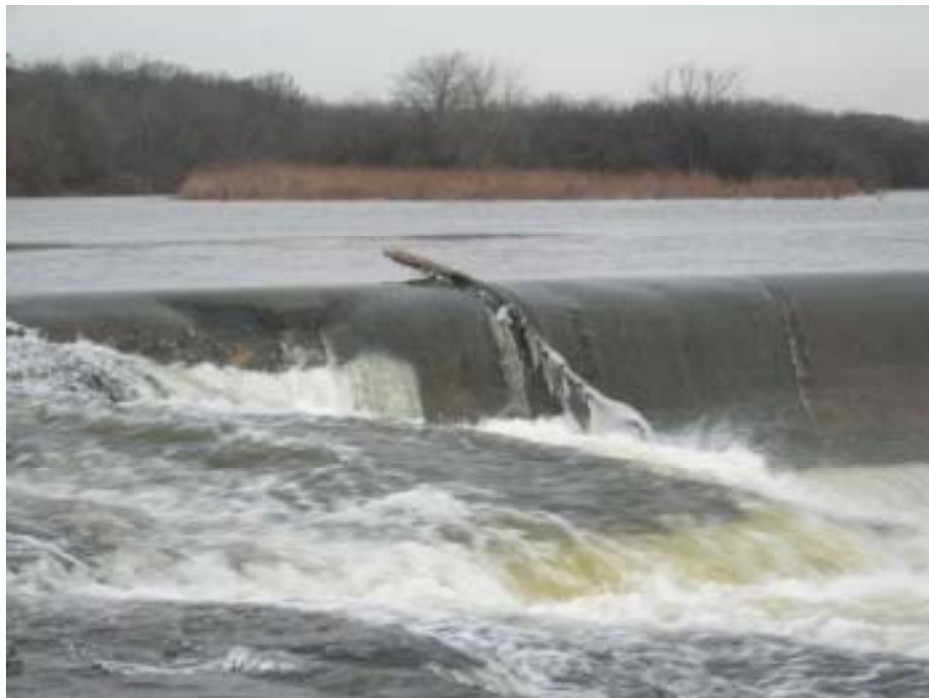
Photo 5.3.8.2 - 8 - Batavia North Dam, Fox River
Left bank, looking upstream.
Apparent buoy and possible sign to river-left of island.

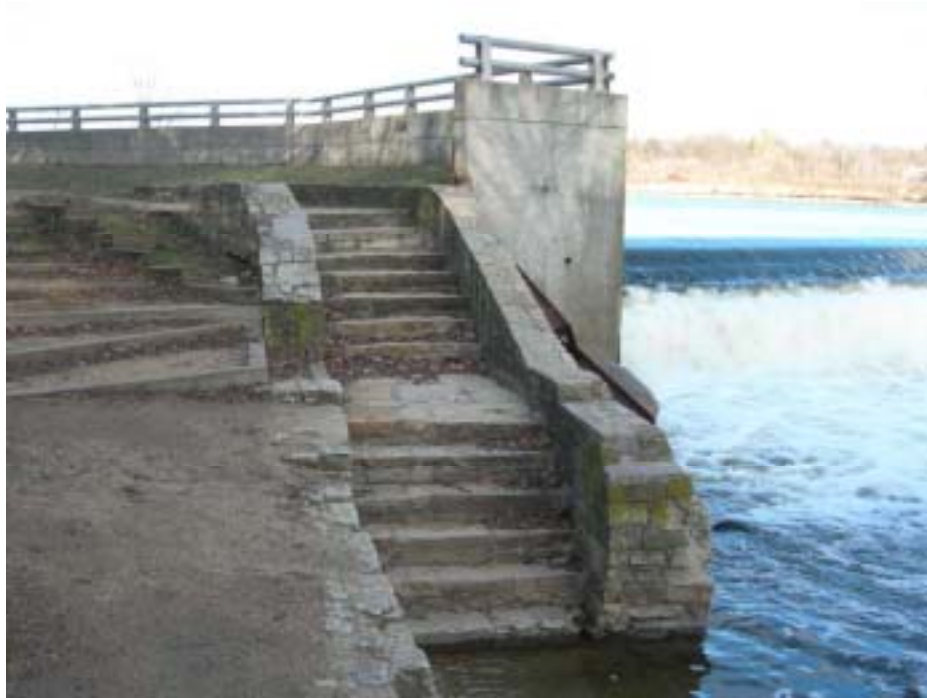
Photo 5.3.9.2 - 1 - North Aurora Dam, Fox River
Right abutment. Stairs to water.

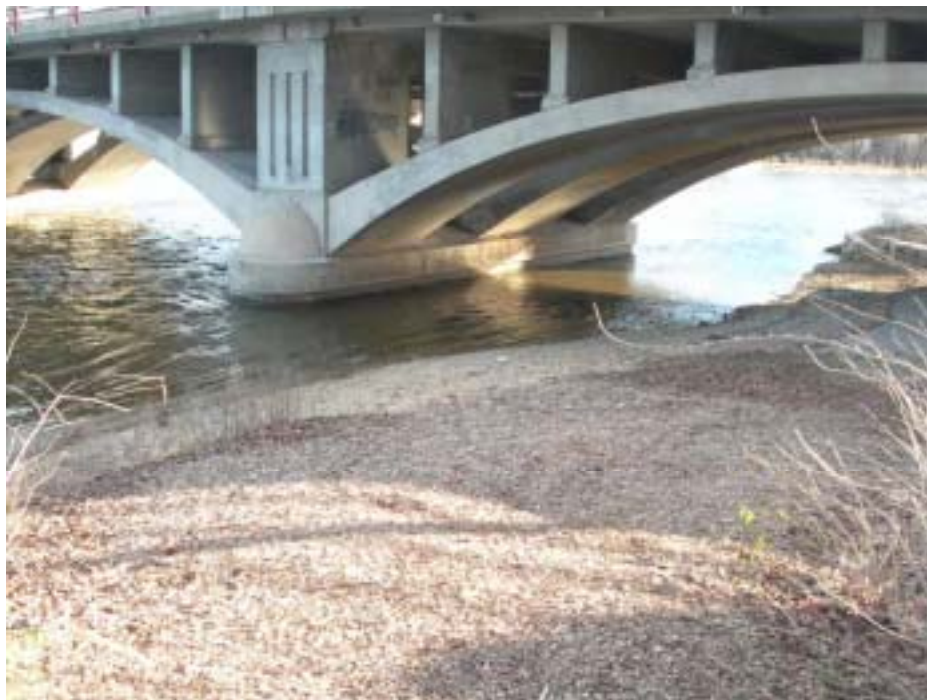
Photo 5.3.9.2 - 2 - North Aurora Dam, Fox River
Right bank, downstream. Portage/boat launch.

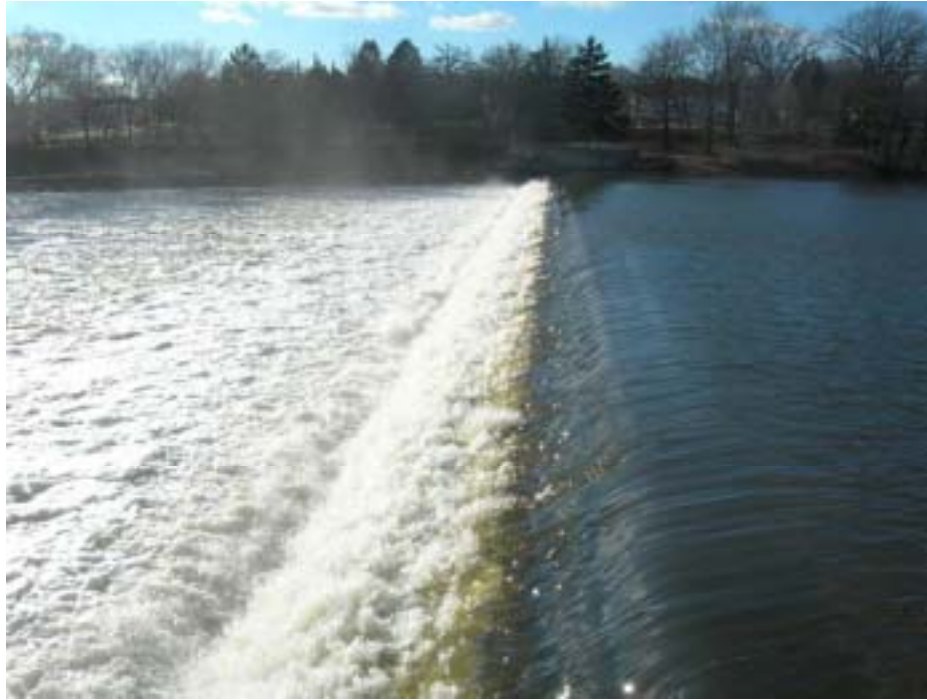
The dam is a step structure. Slight spalling was observed on the first two steps. The right abutment had minor chipping and the left abutment appeared in new condition.

Photo 5.3.9.2 - 3 - North Aurora Dam, Fox River
 Dam face, from left abutment. Note steps in dam.

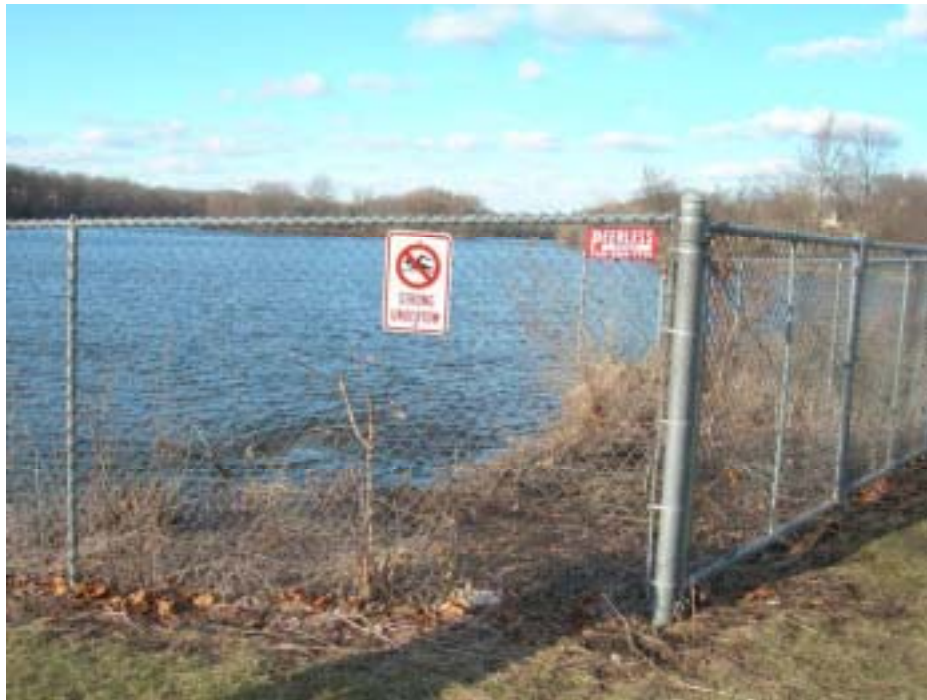
Photo 5.3.9.2 - 4 - North Aurora Dam, Fox River
 Upstream left bank. Intake to downstream millrace. Dangerous whirl pool. No warning sign to river users.

- 4) The millrace located well left of the left abutment has a very rapid current which might present a danger for those attempting to portage there. The millrace is fed by an upstream intake adjacent to the left bank of the river (approximately 250 feet upstream of the dam). This intake creates a hazardous vortex/whirlpool which presents a hazard to river users. The whirlpool is marked to the public from the shore, but there is no indication of the whirl pool to river traffic, except a fence structure, which might attract the attention of a curious canoeist.

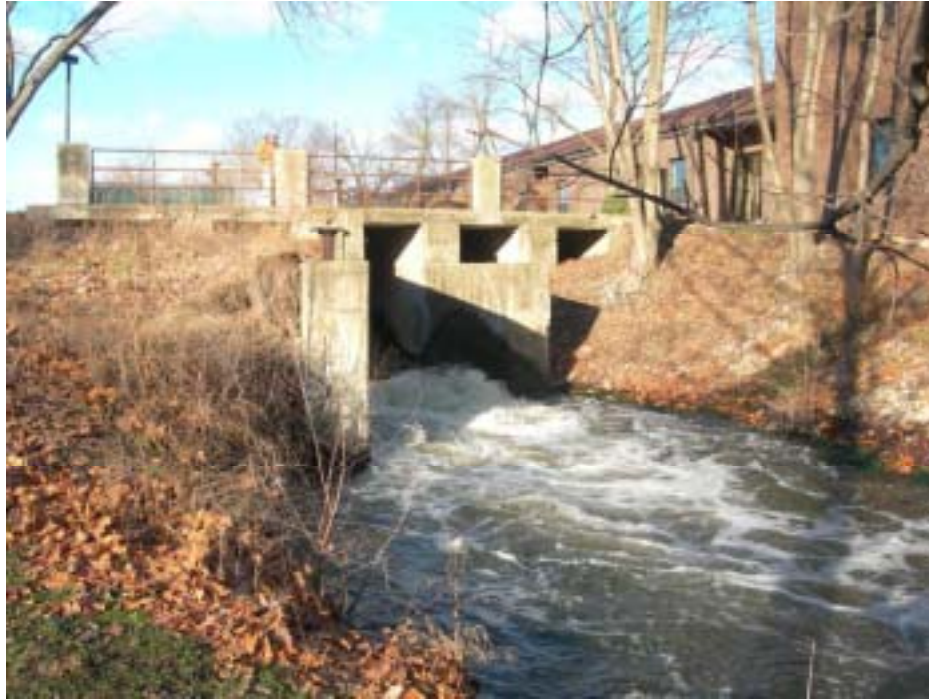
Photo 5.3.9.2 - 5 - North Aurora Dam, Fox River
At millrace outlet from Fox River. Strong current.

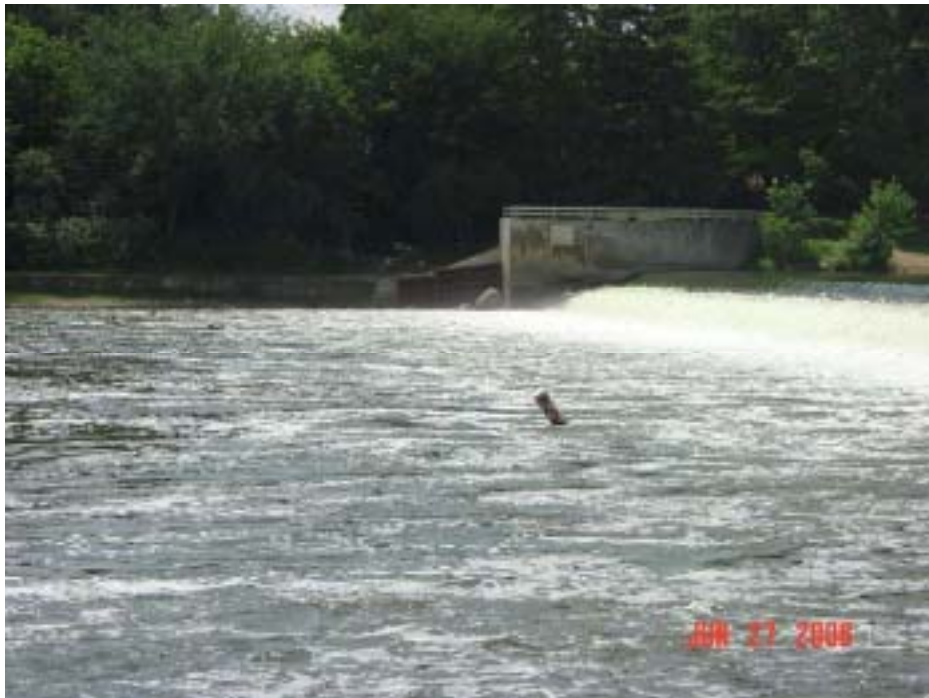
Photo 5.3.9.2 - 6 - North Aurora Dam, Fox River
Seasonal Warning Buoy at Downstream. (IDNR, 2006)

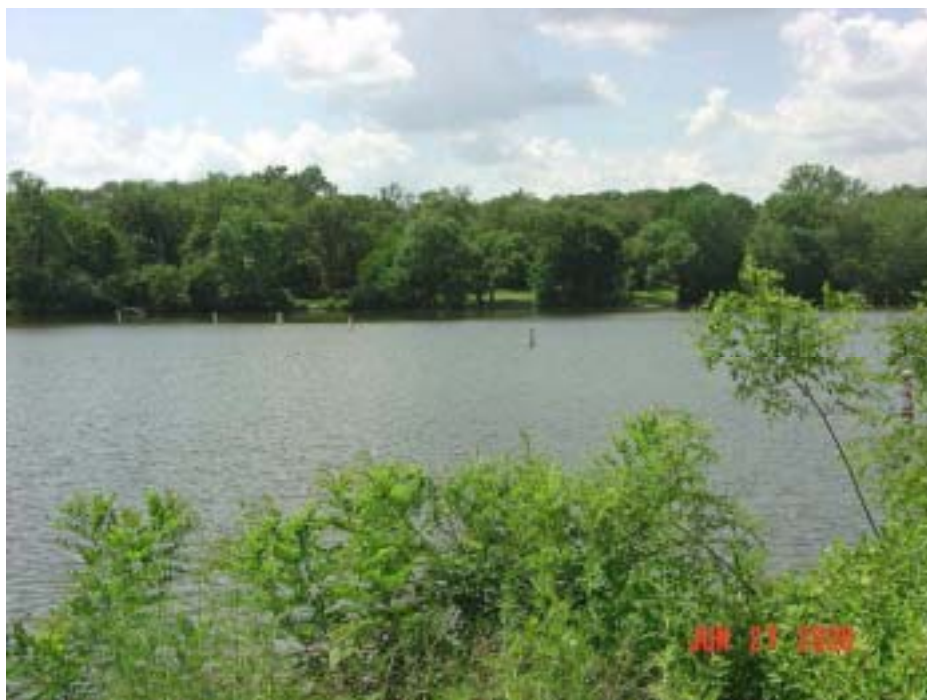
Photo 5.3.9.2 - 7 - North Aurora Dam, Fox River
Seasonal Warning Buoys at Upstream. (IDNR, 2006)

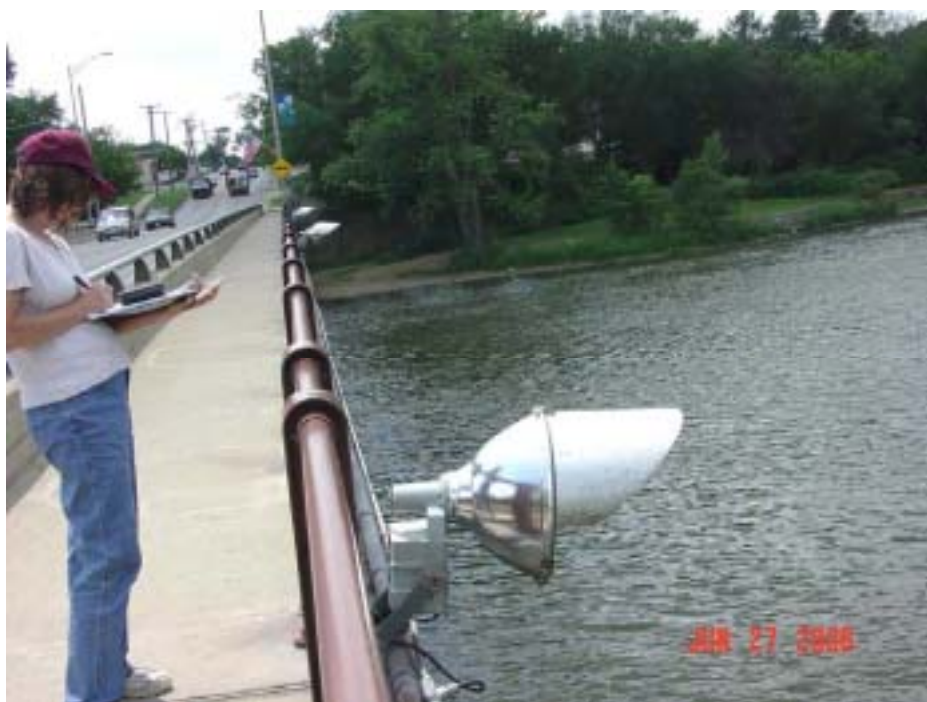
Photo 5.3.9.2 - 8 - North Aurora Dam, Fox River
Three (3) spotlights at Downstream Bridge. (IDNR, 2006)

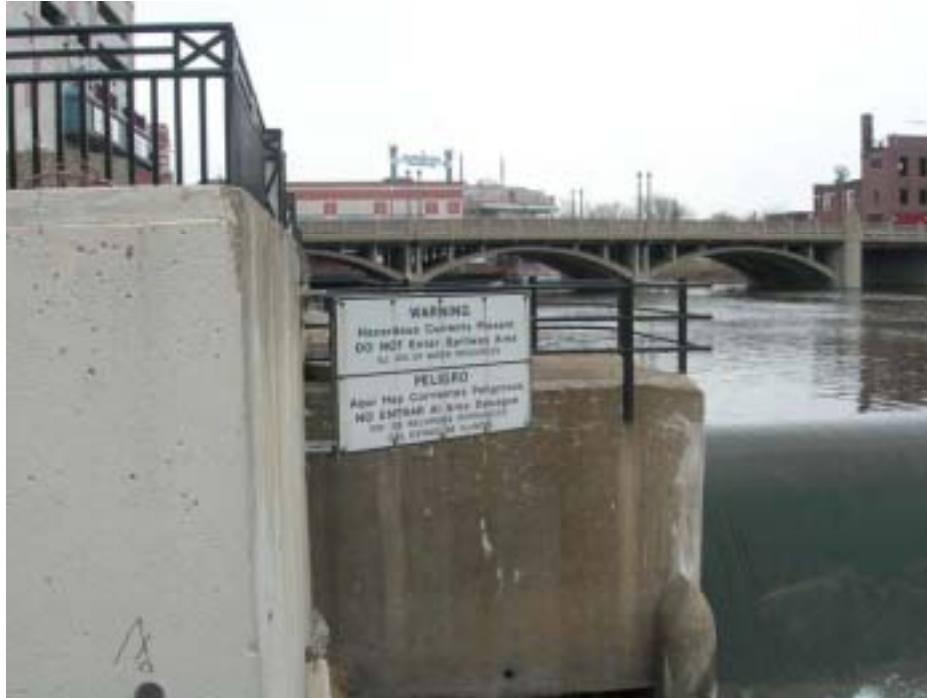
The right abutment is damaged. There is an approximately 6' by 6' section of eroded concrete, undermining the abutment wall. Vegetation is growing in this area. This requires immediate maintenance. Other vertical walls upstream and downstream of dam exhibit minor surface cracking.

Photo 5.3.10.2 - 1 - Aurora East Dam, Fox River
Right abutment. Standard OWR warning sign.

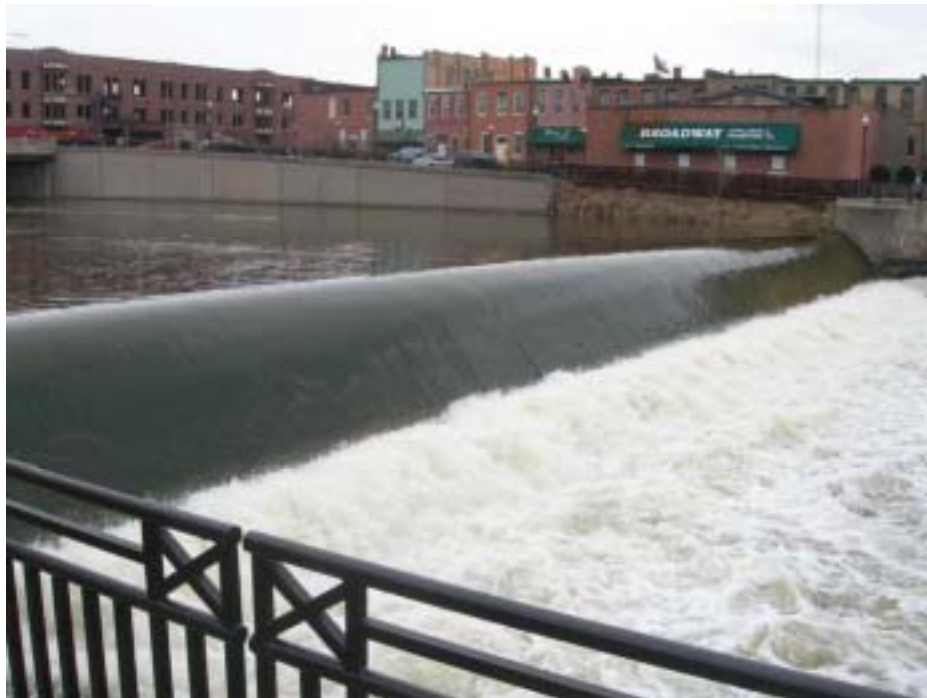
Photo 5.3.10.2 - 2 - Aurora East Dam, Fox River
Dam face, taken from right abutment.

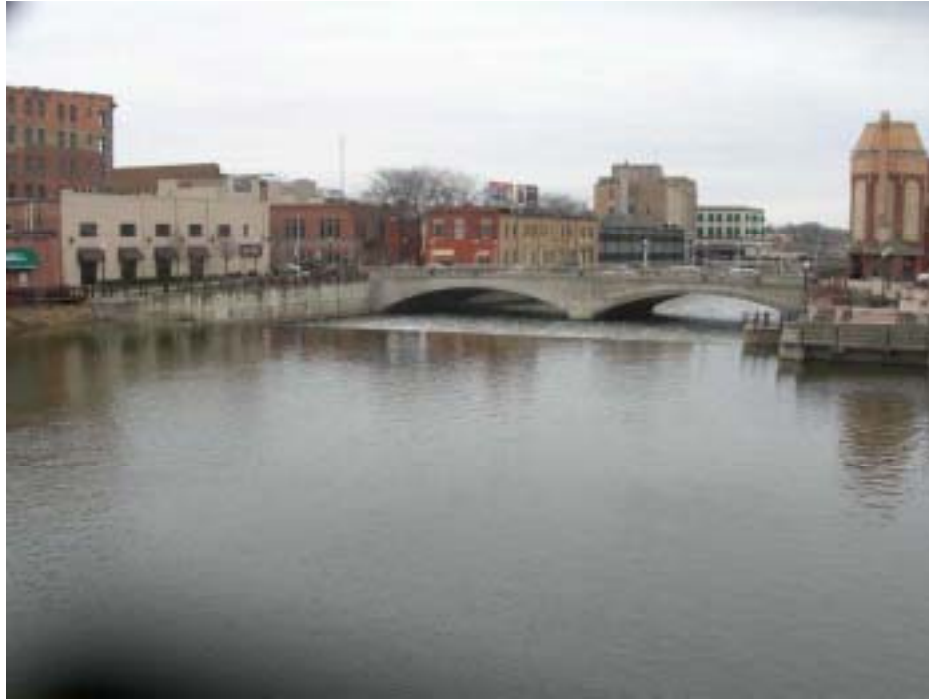
Photo 5.3.10.2 - 3 - Aurora East Dam, Fox River
View of dam, from upstream bridge.

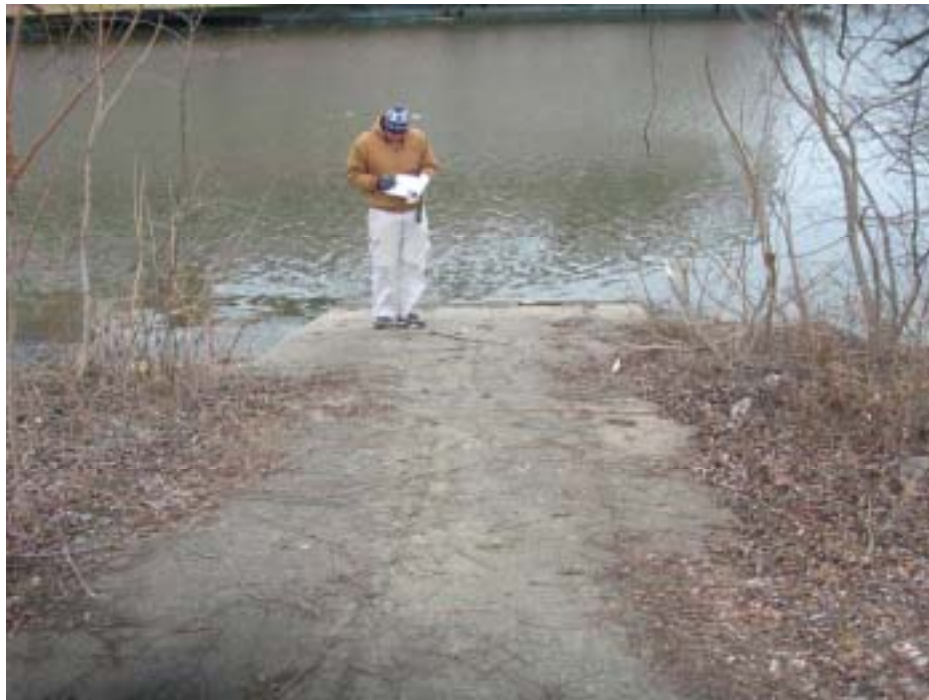
There is an unmarked, relatively steep portage/boat launch on the left upstream bank. However, this portage is downstream of the seasonal warning buoys. A downstream, upstream of the immediate upstream bridge left bank portage. The west dam was a canoe chute which may or may not be in operation, according to a paddler's website. A portage may also exist in this area, but was not observed.

Photo 5.3.10.2 - 4 - Aurora East Dam, Fox River
Left upstream bank. Boat launch/portage. Located downstream of summer warning buoys.

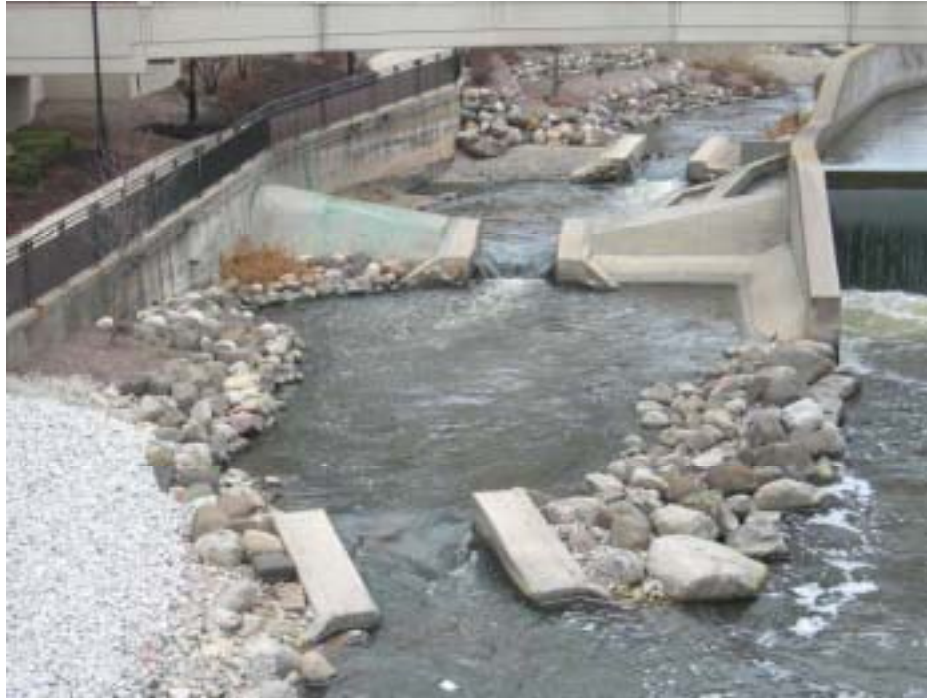
Photo 5.3.10.2 - 5 - Aurora East Dam, Fox River
Aurora West Dam. View of canoe/kayak chute.

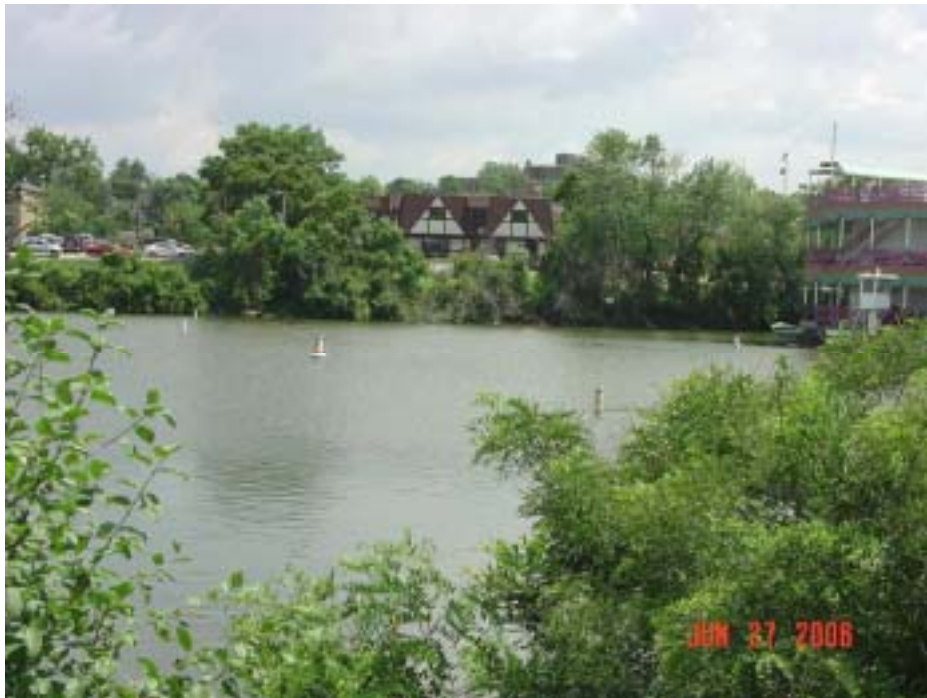
Photo 5.3.10.2 - 6 - Aurora East Dam, Fox River
Seasonal Warning Buoys. (IDNR, 2006)

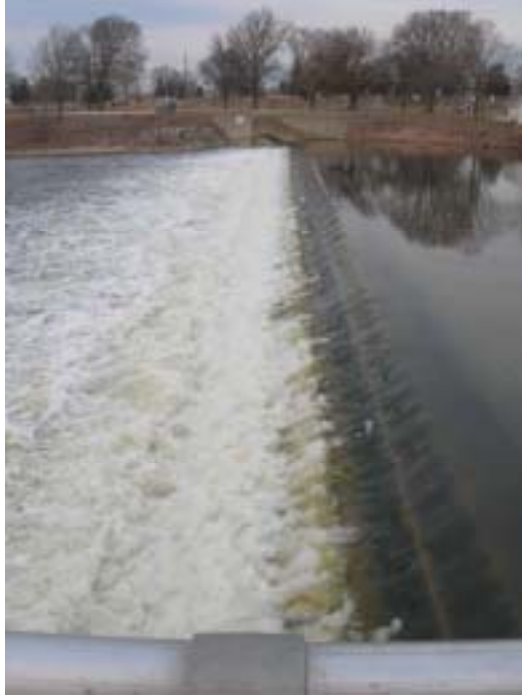
Photo 5.3.11.2 - 1 - Montgomery Dam, Fox River
Dam face, from left abutment.

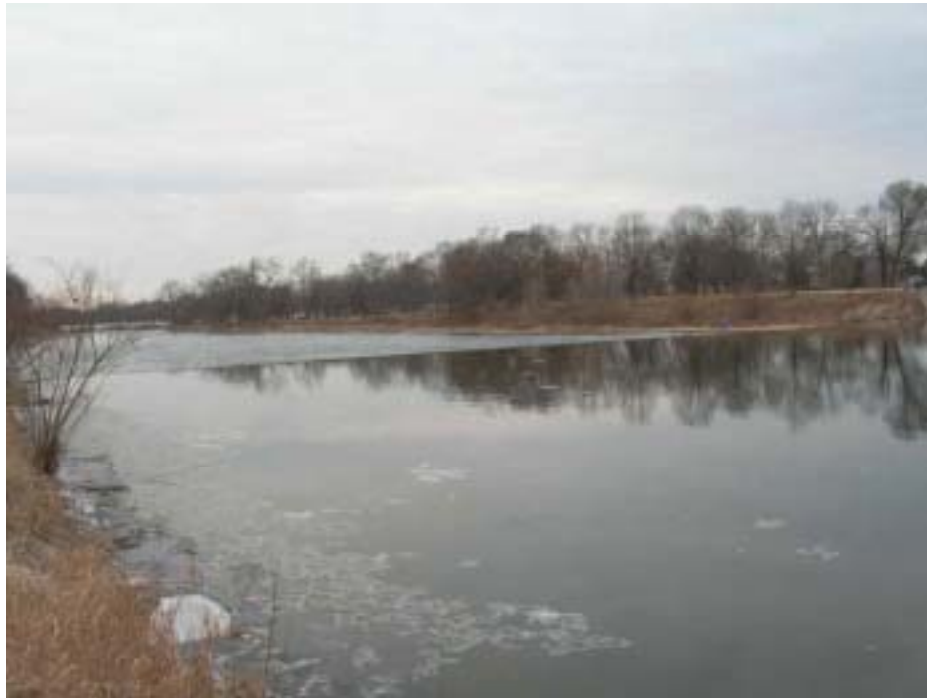
Photo 5.3.11.2 - 2 - Montgomery Dam, Fox River
View of dam, from upstream left bank.

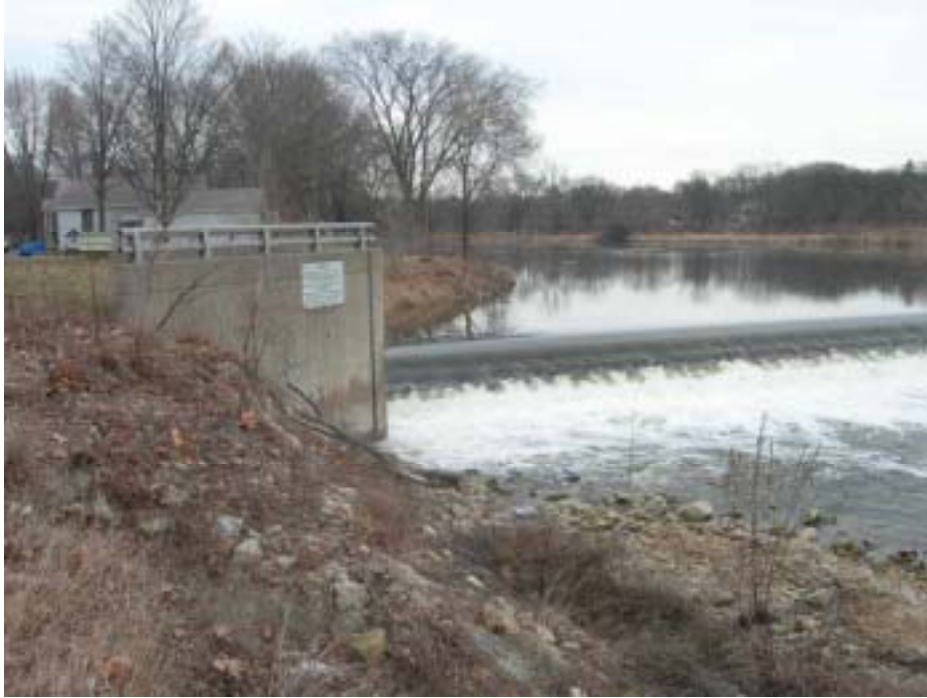
Photo 5.3.11.2 - 3 - Montgomery Dam, Fox River
Right abutment and dam face. Standard OWR warning sign.

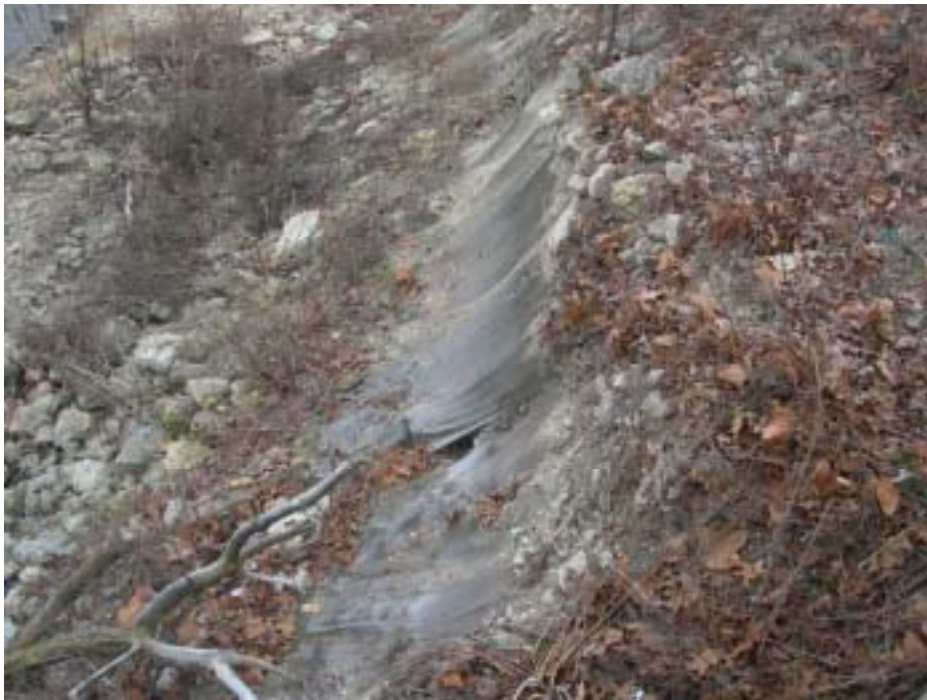
Photo 5.3.11.2 - 4 - Montgomery Dam, Fox River
Right bank, just downstream of dam. Note erosion.

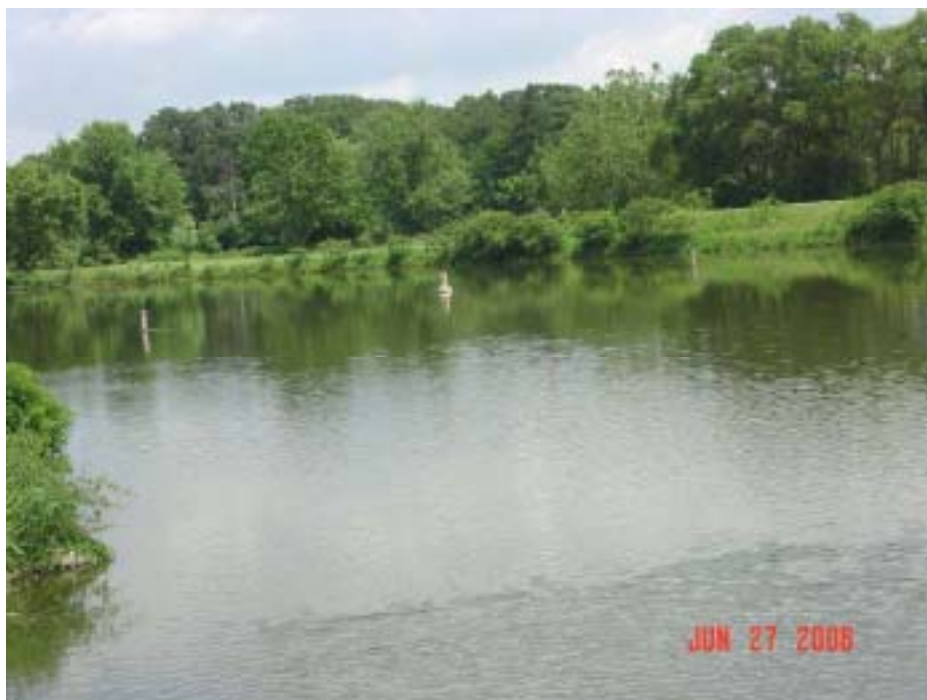
Photo 5.3.11.2 - 5 - Montgomery Dam, Fox River
Seasonal Warning Buoys. (IDNR, 2006)

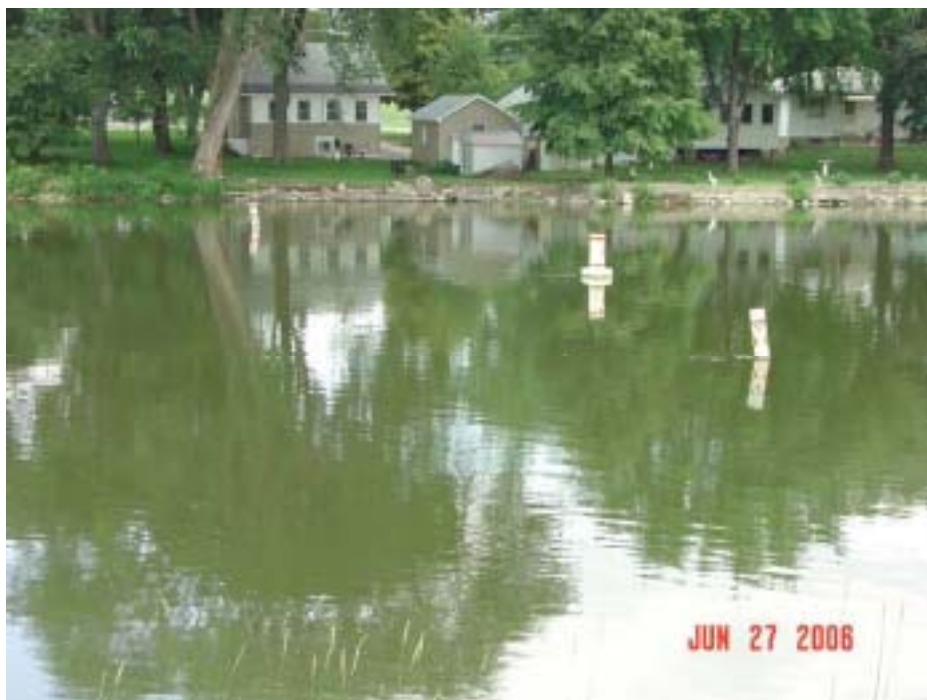
Photo 5.3.11.2 - 6 - Montgomery Dam, Fox River
Seasonal Warning Buoys. (IDNR, 2006)

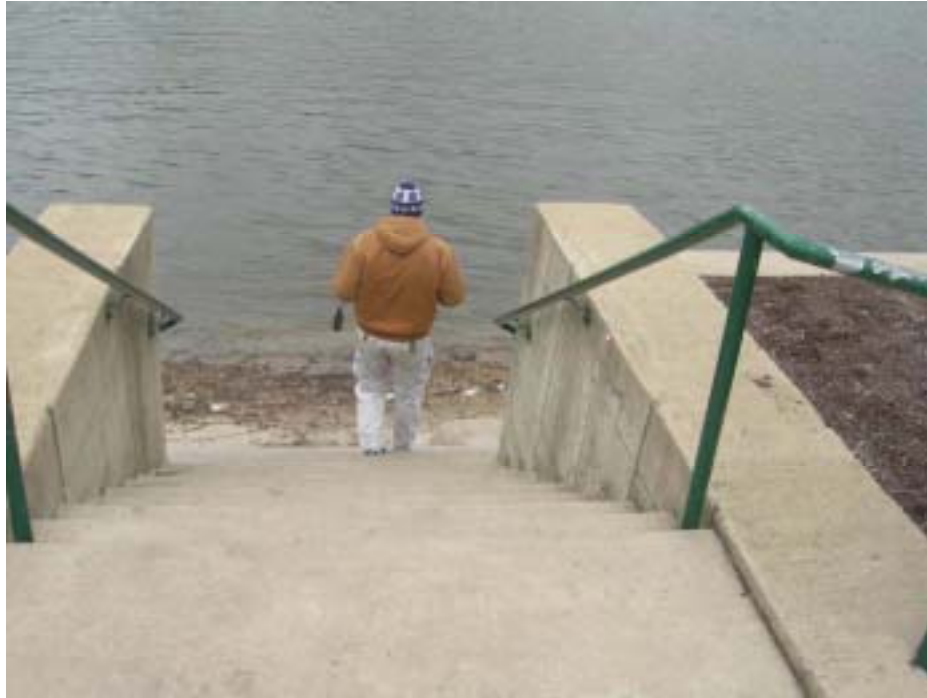
Photo 5.3.12.2 - 1 - Yorkville Dam, Fox River
Left downstream. Stairs/portage.

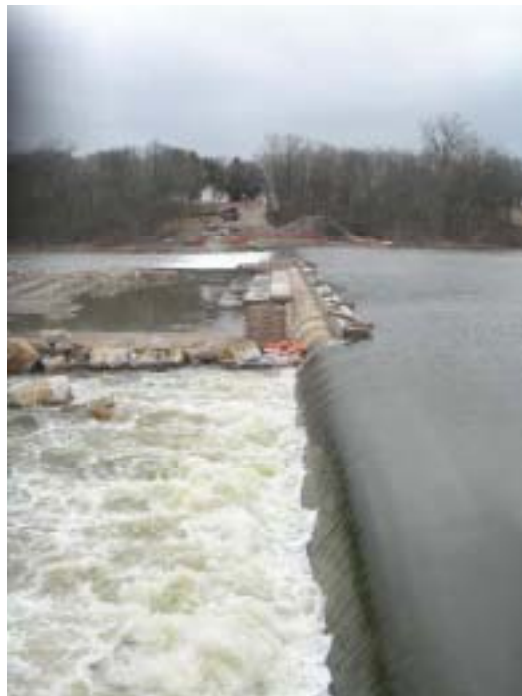
Photo 5.3.12.2 - 2 - Yorkville Dam, Fox River
Dam face from left abutment. Note large roller. Under construction.

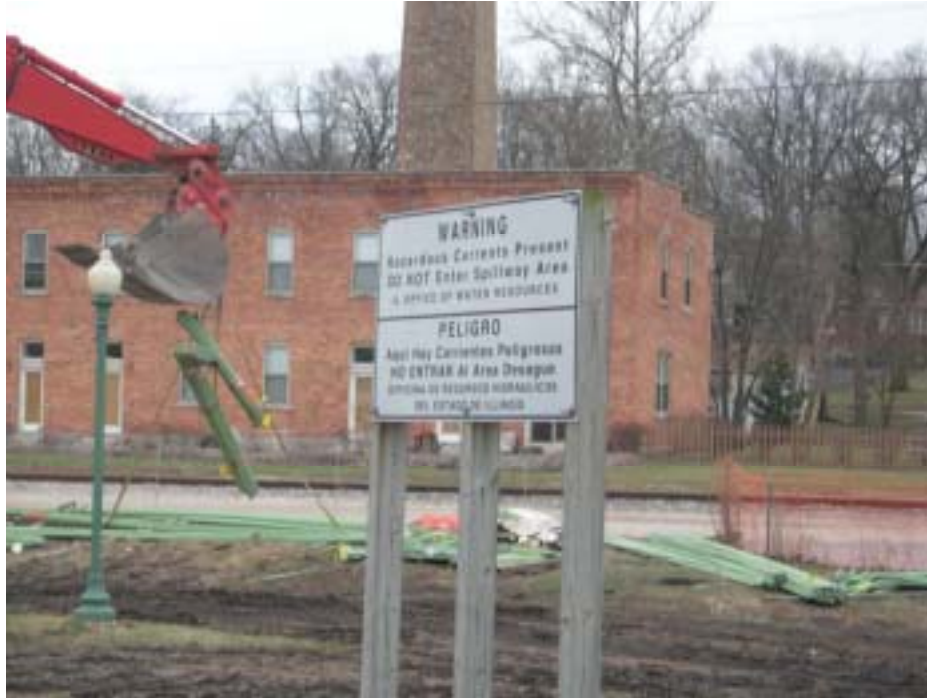
Photo 5.3.12.2 - 3 - Yorkville Dam, Fox River
Left bank at dam face. Standard OWR signage.

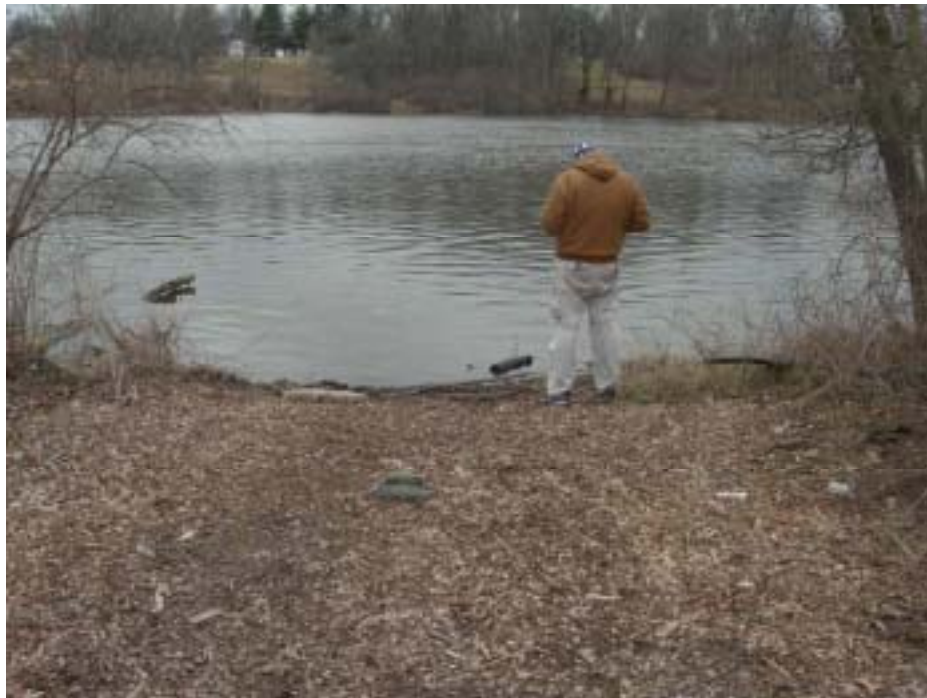
Photo 5.3.12.2 - 4 - Yorkville Dam, Fox River
Left bank, upstream portage.

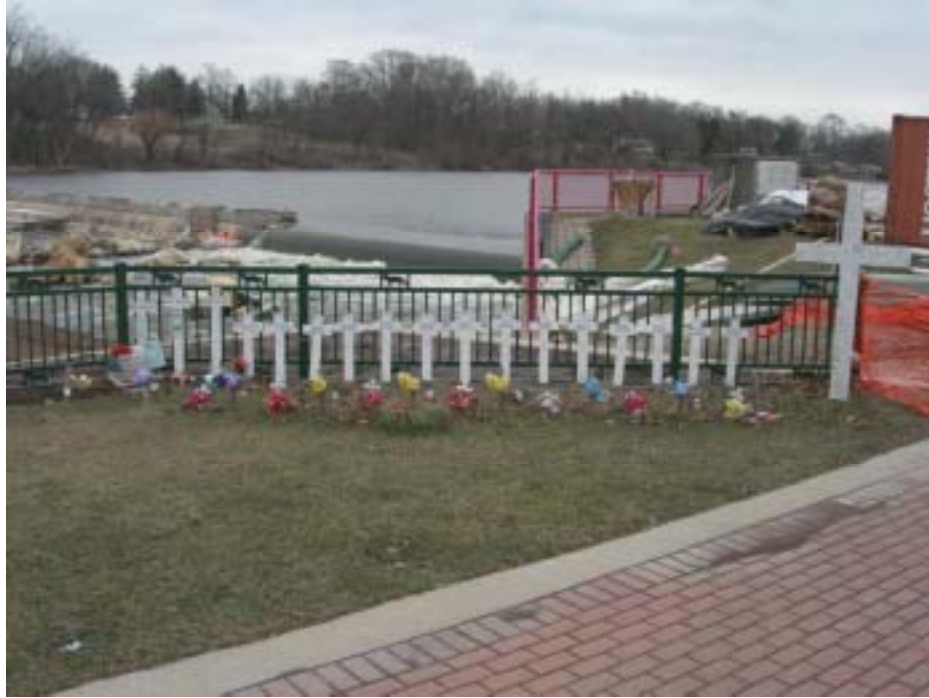
Photo 5.3.12.2 - 5 - Yorkville Dam, Fox River
Left abutment. Memorial to 17 drowning victims.

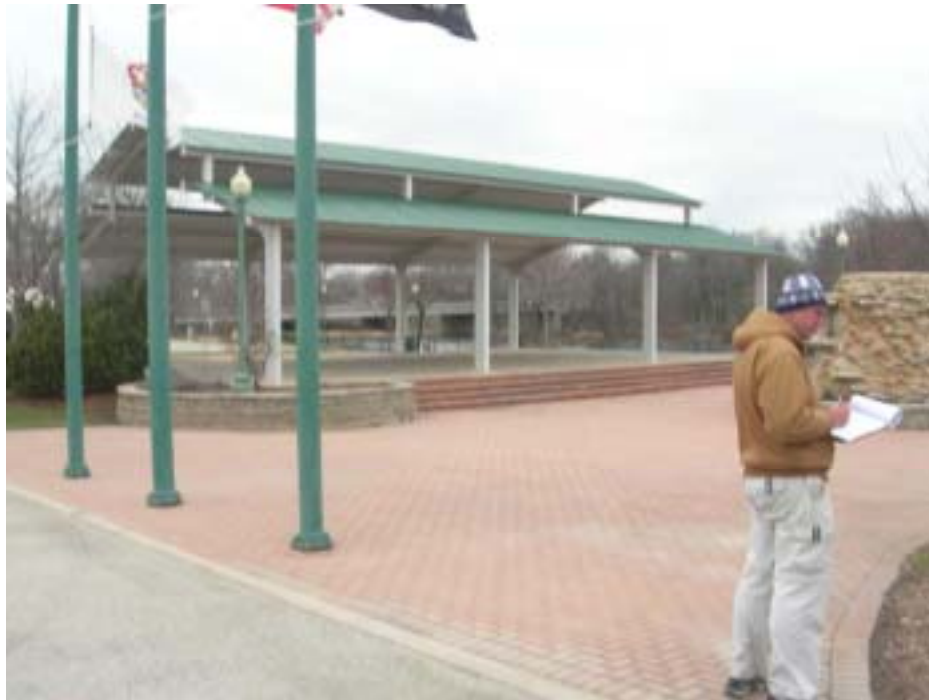
Photo 5.3.12.2 - 6 - Yorkville Dam, Fox River
Left bank pavilion. Potential location for educational kiosk.
